Dow Corning silicones hold back ‘sea of water’

Dallas landmark gets leak protection and facelift

Top-to-bottom silicone fix ends hospital's history of leaks

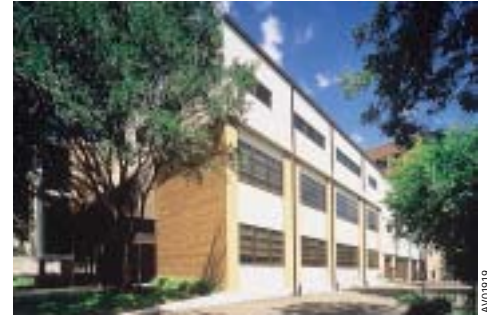
*Texas Association of School Administrators
headquarters building, Austin, Texas*

Before the three-story, stucco and brick Texas Association of School Administrators building received a Dow Corning rehabilitation, a big storm was big trouble. “The building was a sea of water,” says Roy Conrad of Gorman Moisture Protection, Inc., of El Paso, Texas. “Water literally poured in from every direction.”

Dow Corning® 123 Silicone Seal, a preformed silicone extrusion, bridged joints from the walls to roof flashing and was also used on metal-to-metal joints, on the aluminum window sill flashing and across stucco control joints. Then, *Dow Corning® 795 Silicone Building Sealant* was used to replace the failed urethane caulk around the aluminum and steel windows.

Finally, the exterior stucco was coated with *Dow Corning® AllGuard Elastomeric Coating* in a bone-white color and the metal casement windows in a bronze color, sealing the building against leaks and giving it a bright appearance. The coating, which comes with a 10-year weatherproofing guarantee, acts as a breathable waterproof covering, allowing water vapor trapped in the substrate to escape without compromising its water repellency.

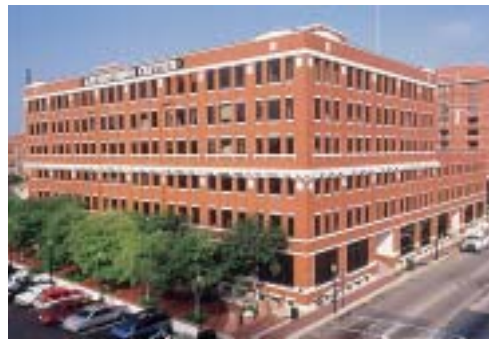
Landmark Center, Dallas, Texas

Dow Corning® 795 Silicone Building Sealant and used *Dow Corning® 123 Silicone Seal*, a preformed extrusion with remarkable movement capabilities, to seal the metal-to-metal joints in the new aluminum coping cap around the roof.

The final touch following the repair, power washing and priming of the brick facade, was two coats of *Dow Corning® AllGuard Elastomeric Coating* in a custom color that matched the building’s previous paint, plus various accents in a lighter color for contrast. The silicone coating was just what the building needed – an additional layer of durable, waterproof leak protection, plus the enduring color that a building like the Landmark Center deserves.

Built in 1913, the six-story brick and concrete Landmark Center was renovated in 1980, but by 1996 it “leaked profusely,” according to Joseph Solinski, president of Stone & Glazing Consulting, Inc., of Dallas, Texas. Solinski isolated a number of problems, including improper window flashing, failed urethane perimeter sealing and crumbling brick mortar. He recommended a silicone solution.

April Building Services of Dallas resealed the windows and small mortar cracks with

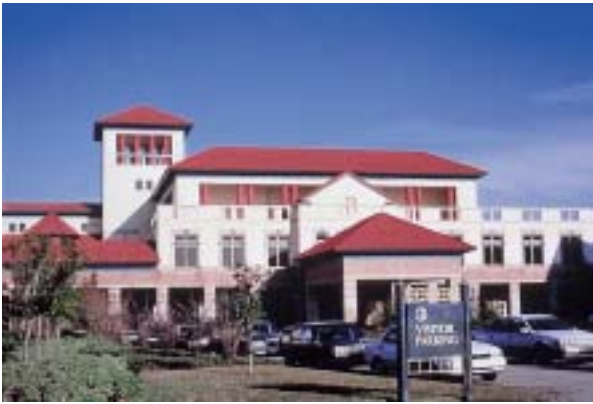
Flagler Hospital, St. Augustine, Florida

The 200,000-square-foot Flagler Hospital complex in St. Augustine, Florida, began to leak soon after opening in 1989. All simple remedies failed, and the problem worsened. "We were getting water into this building at practically every opening," says Jim Conzemius, president of Flagler Hospital.

Dow Corning[®] 123 Silicone Seal, a preformed extrusion, was used in a variety of ways that saved time and labor. *Dow Corning*[®] 795 Silicone Building Sealant was used to replace failed urethane caulks at glass-to-metal window joints and *Dow Corning*[®] 790 Silicone Perimeter Sealant at glass-to-stucco perimeter joints.

After unsightly mold was cleaned from the building's exterior and the walls primed, the fourth Dow Corning product was used. Several coats of *Dow Corning*[®] AllGuard Elastomeric Coating were power-rolled on the walls, a misty white color and a custom light green. This durable silicone coating provides an effective, long-lasting waterproof barrier to above-grade exterior walls, leaving Flagler Hospital ready to take on the harsh Florida coastal environment.
